*Certification Docket for the  
Remedial Action Performed  
at the General Motors Site in  
Adrian, Michigan*

*Department of Energy  
Office of Assistant Manager  
for Environmental Management  
Oak Ridge Operations*

*January 2001*

CERTIFICATION DOCKET  
FOR THE  
REMEDIAL ACTION PERFORMED AT THE  
GENERAL MOTORS SITE  
ADRIAN, MICHIGAN

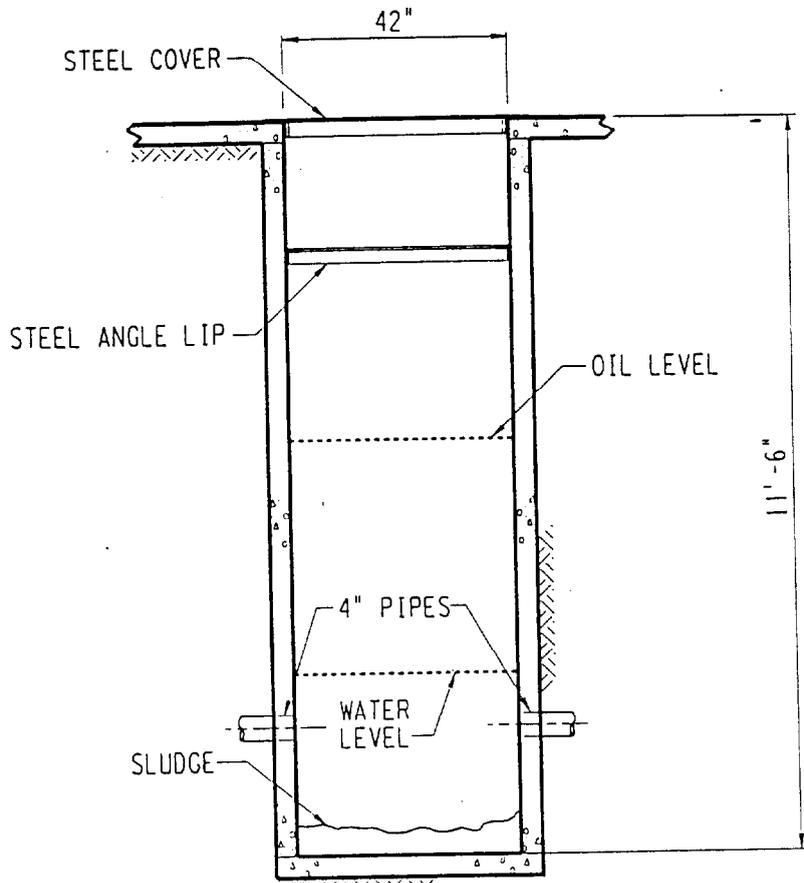
Figure I-8  
Sump 3 Before Remedial Action

1. RUST WAS PREVALENT ON ALL METAL COMPONENTS.
2. BRICK WAS DETERIORATED.
3. STEEL ACCESS LADDER WAS RUSTED.
4. SUMP PUMPS, LADDER, ELECTRICAL CONDUITS WERE NOT SHOWN IN THE SECTION FOR CLARITY.
5. SEE GENERAL LOCATION ON FIGURE I-3.

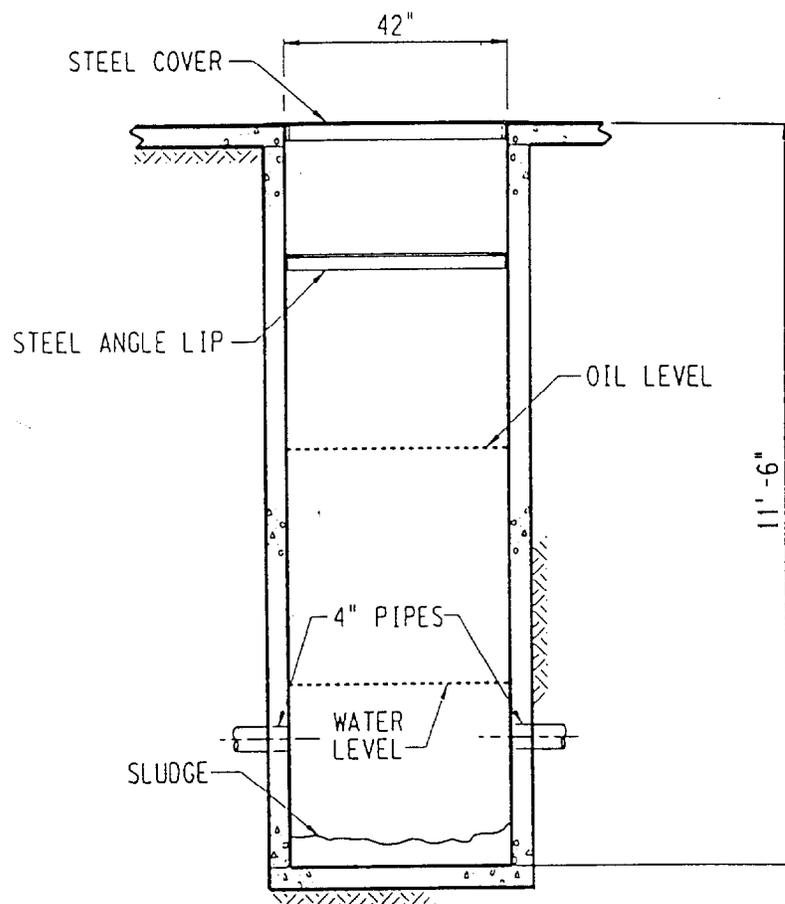
1. RUST WAS PREVALENT ON ALL METAL COMPONENTS.
2. BRICK WAS DETERIORATED.
3. STEEL ACCESS LADDER WAS RUSTED.
4. SUMP PUMPS, LADDER, ELECTRICAL CONDUITS WERE NOT SHOWN IN THE SECTION FOR CLARITY.
5. SEE GENERAL LOCATION ON FIGURE I-3.
